**PUBLIC NOTICE**  
 Notice is hereby given as required by M.G.L. Chapter 87 § 3 that the Tree Warden of the Town of Greenfield will hold a Public Hearing on **May 12, 2015 at 10:00 a.m.** in the Town Hall Meeting Room (2nd Floor), 14 Court Square, Greenfield, Massachusetts for the removal of trees from the following locations:

Comments and resources for the Tree Warden and DPW of Greenfield

RE: Trees and Sidewalks

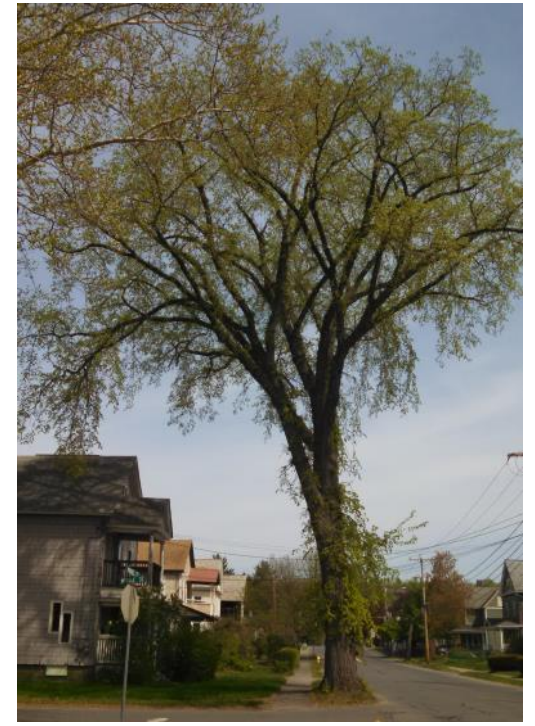
**1. 21 Pierce St: American Elm (Ulmus Americana)**

DBH: 42" Ht: 65' Dead Branches: N Remove? No  
 Signs of Disease: N  
 Sidewalk issues: Y OH Utilities: N Annual Benefit Value: \$449  
 Notes: Tree is fully leafed out w no sign of hazard to the public, except for the sidewalk

From Christian Marks at the Nature Conservancy:  
 "there is no reason to cut down a beautiful healthy mature American elm like this one, especially because such elms have become so rare. Such elms were once the classic street trees of New England towns and this specimen is a way to connect us with that heritage. Perhaps there is an alternative, such as moving the sidewalk over by a couple of feet over into the lawn to avoid the trees roots."  
 "interested in such exceptionally large surviving American elms if there is reason to believe that the tree has a higher than usual tolerance to the disease. My research partners and I try to propagate such survivor elms"

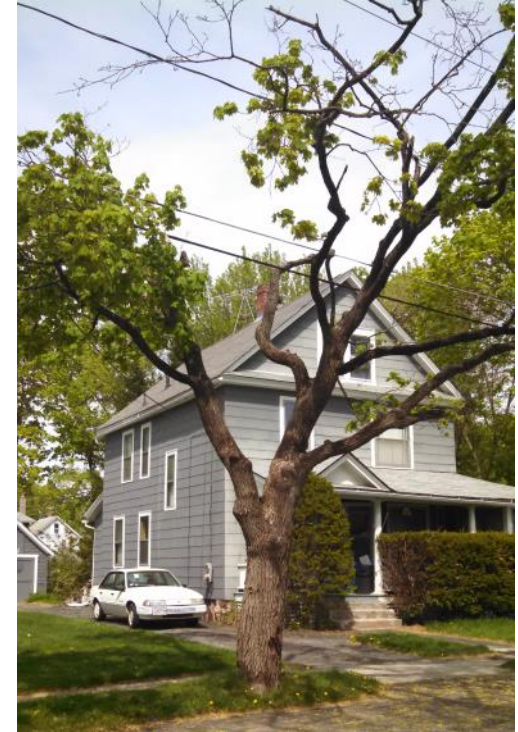
**2. 23 Holly Street: Norway Maple (Acer platanoides)**

DBH: 19" Ht: 25' Dead Branches: Y, several Remove? Probably  
 Signs of Disease: Minor  
 Sidewalk issues: N OH Utilities: Y Annual Benefit Value: \$179  
 Notes: Tree has poor form, several dead branches

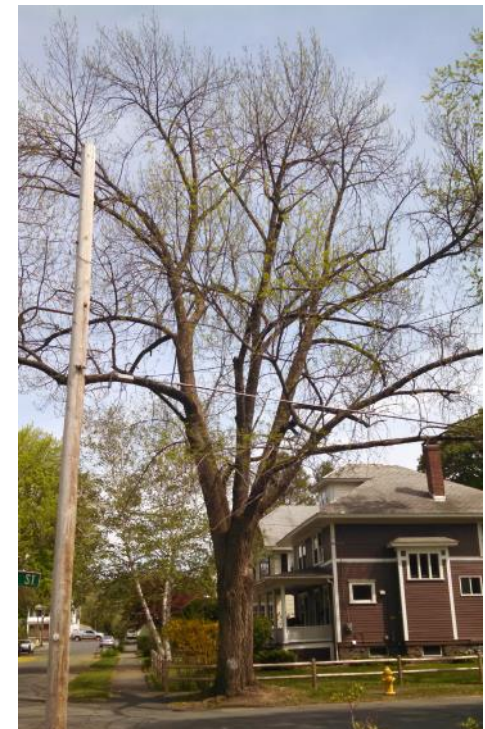
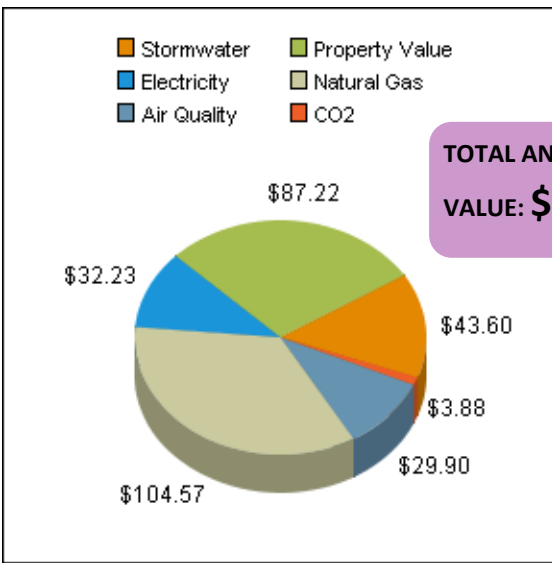
**3. 18 Linden Ave: White Ash (Fraxinus Americana)**

DBH: 36" Ht: 55' Dead Branches: N Remove? No  
 Signs of Disease: some  
 Sidewalk issues: N OH Utilities: N Annual Benefit Value: \$179  
 Notes: Tree fully leafed out, no crown die back or signs of stress; excellent condition; conflict w sidewalk

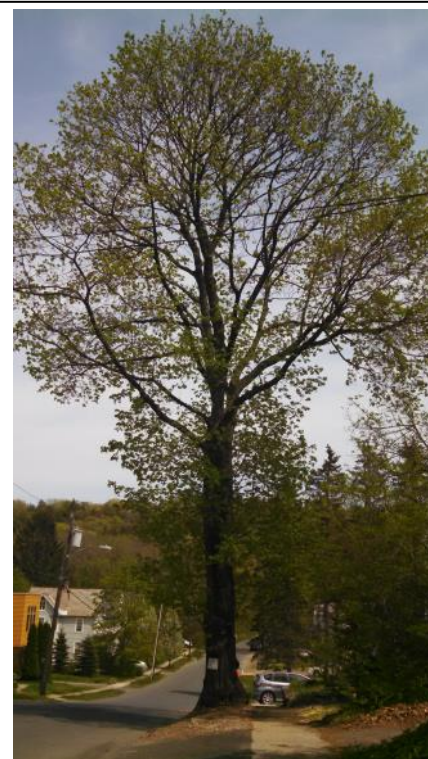
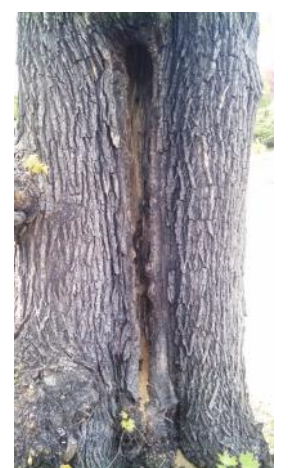
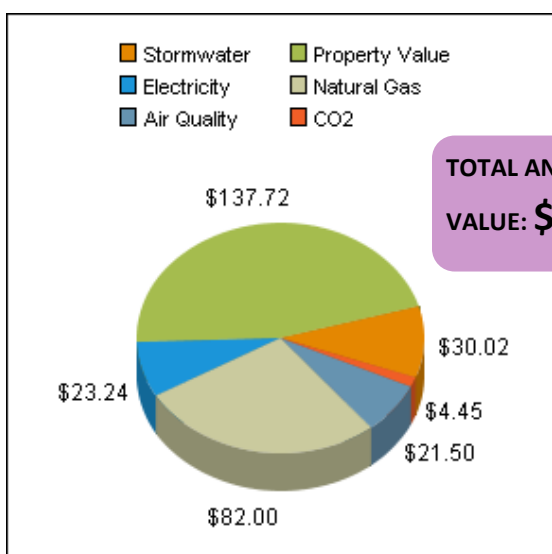
**4. 4 Spring Terrace: Norway Maple (Acer platanoides)**

DBH: 30" (approx.) Ht: 50' Dead Branches: N Remove? No  
 Signs of Disease:  
 Sidewalk issues: Y OH Utilities: N Annual Benefit Value: \$299  
 Notes: Tree has some decay in trunk <10%; fully leafed out, no crown die back or signs of stress

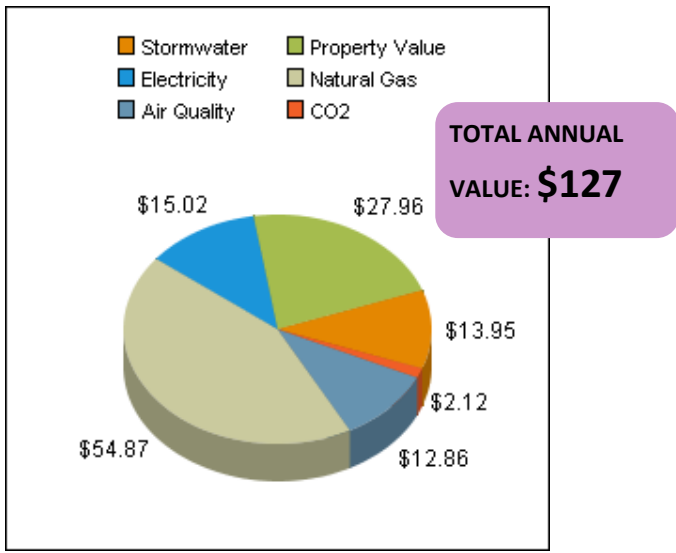
**5. Wright Avenue: Norway Maple (Acer platanoides)**

DBH: 18" (approx.) Ht: 35' Dead Branches: Y  
 Sidewalk issues: N OH Utilities: Y Annual Benefit Value: **\$127**  
 Notes: Tree leaning on utility w wire entangled; half dead

**Remove? Yes**  
 Signs of Disease:

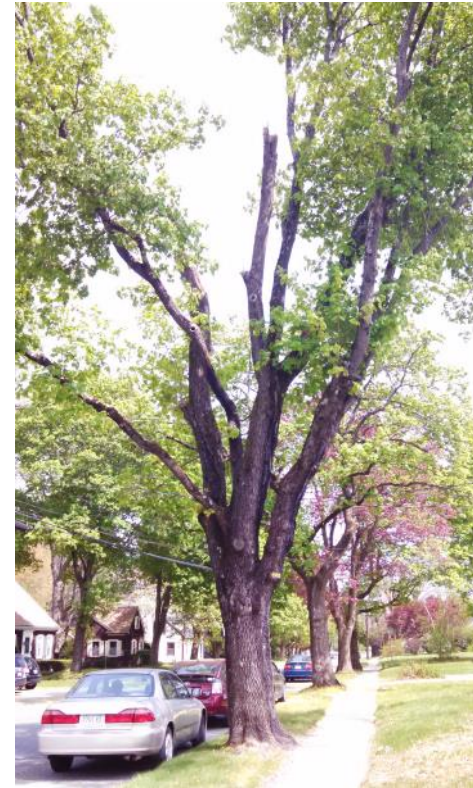
**6. 24 Wildwood Ave: Norway Maple (Acer platanoides)**

DBH: 24" (approx.) Ht: 35' Dead Branches: Y  
 Sidewalk issues: Minor OH Utilities: N Annual Benefit Value: **\$232**  
 Notes: An average declining Norway Maple—probably could live several more years w/ pruning

**Remove? No**  
 Signs of Disease: N

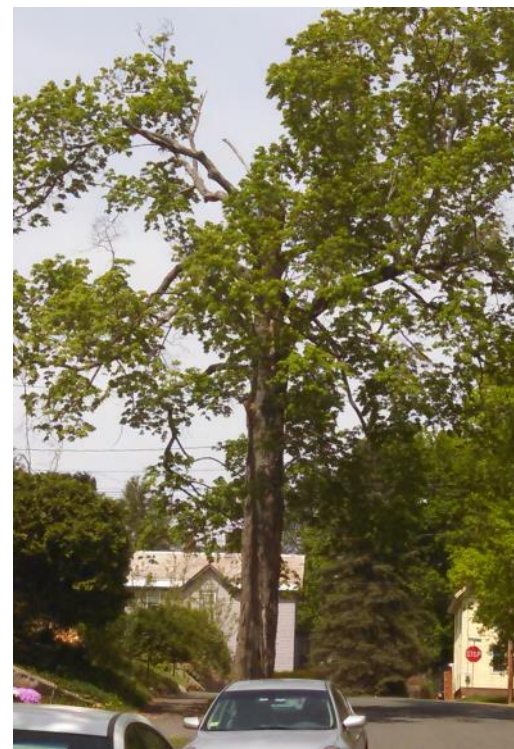
**7. 160 School Street: Sugar Maple (Acer saccharum)**

DBH: 36" Ht: 45' Dead Branches: Minor  
 Sidewalk issues: Y OH Utilities: N Annual Benefit Value: **\$299**  
 Notes: Tree was topped at some point, maybe in a storm. Well leafed out. Minor bark loss at trunk; Does not show signs of decline or hazard

**Remove? No**  
 Signs of Disease: N
